Narberth to Canaston Bridge Engineering Feasibility Report

November 2018

1. Project Overview

2. Scheme Overview

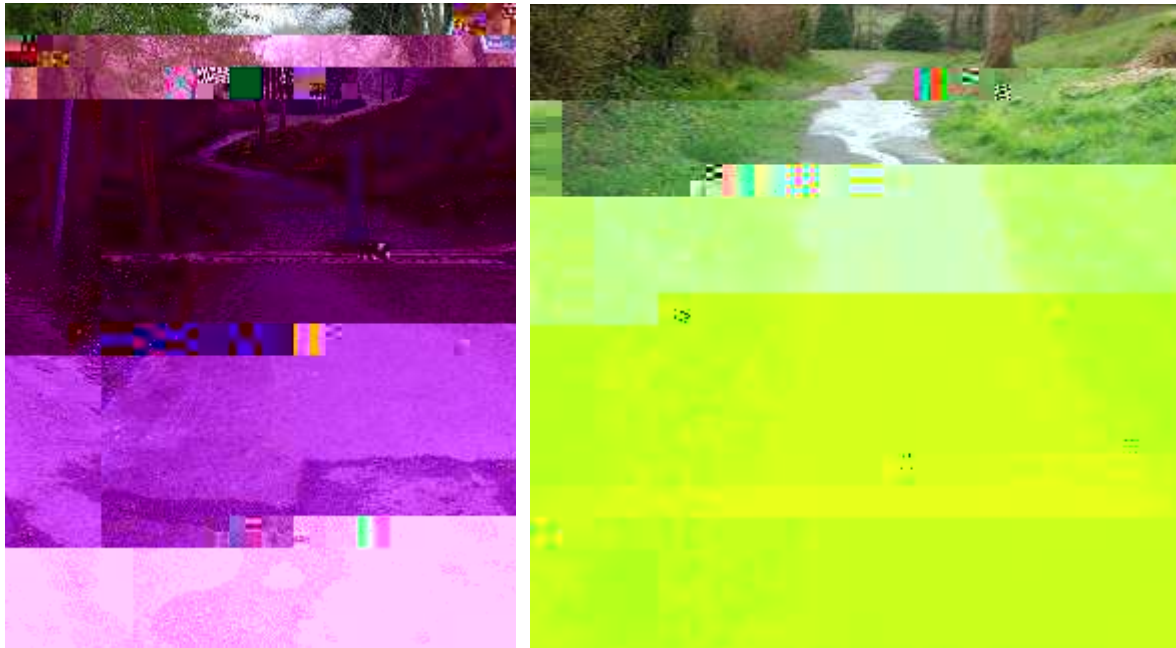
Photo's 3.1 and 3.2 – Path beginning at Narberth.

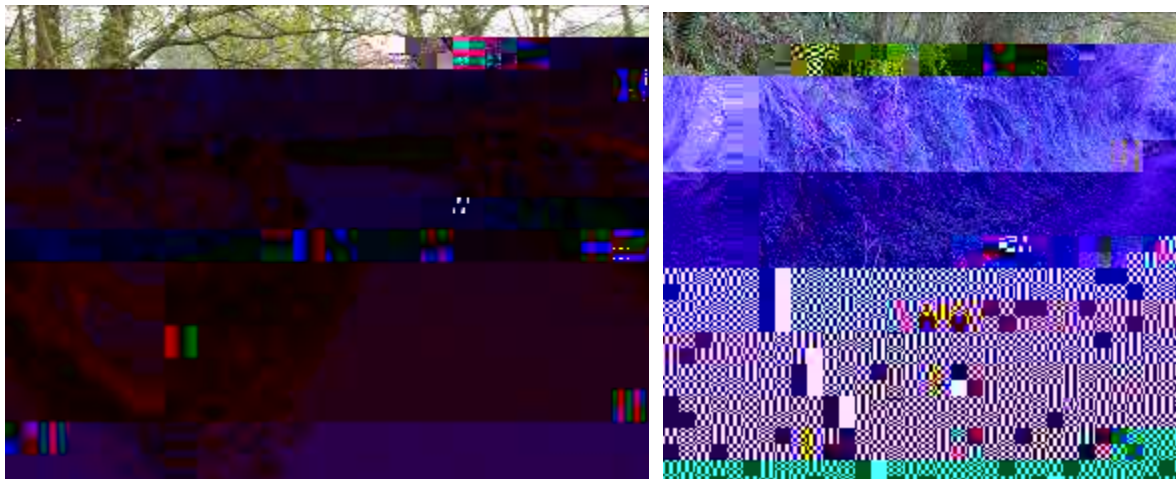
Photo's 3.3 and 3.4 – Path over the bridge / culvert and the path beyond.

After the bridge the path passes through woodland and narrows with a steep bank to one side a slope down on the other. The existing drainage requires improvement with a stream forming along the path after heavy rain. The topography leaves little scope for path widening from an existing width of approximately two metres.

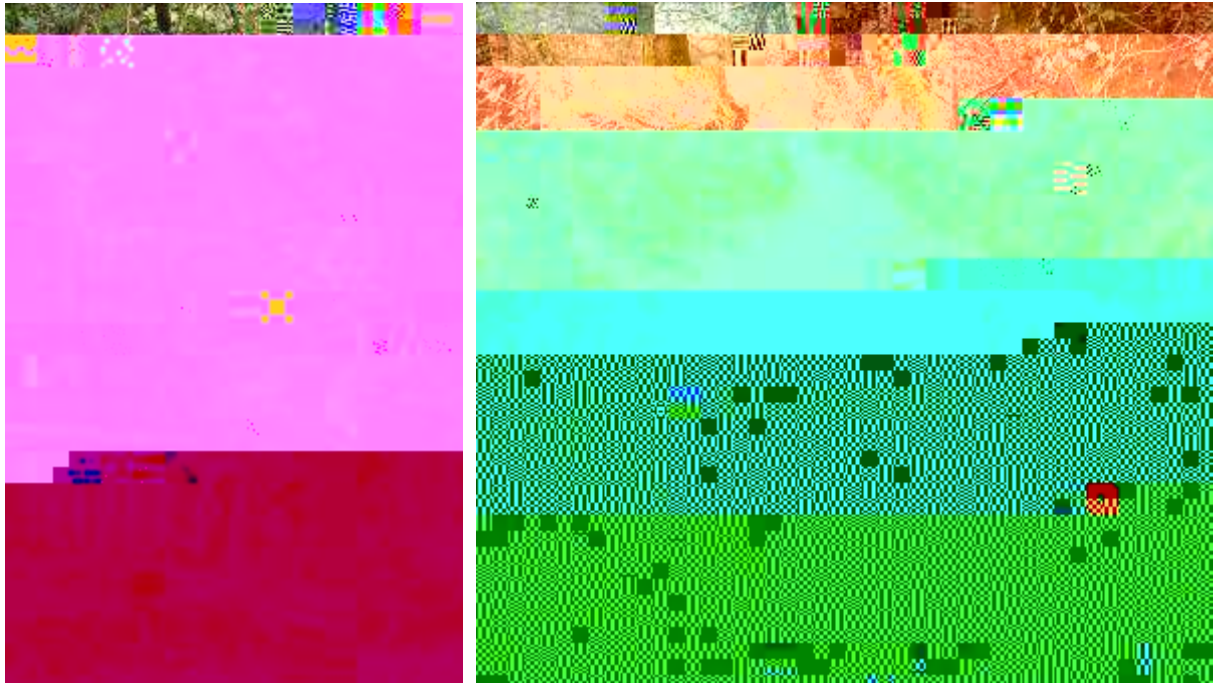
Photo's 3.5 and 3.6 – Existing drainage and overflow.

Further along the path more drainage issues are clear as water bypasses existing drainage channels to form a stream along one side of the path. The route at this point is cut into the hillside, restricting the available width which is restricted further at 'pinch points' in places where trees are present.

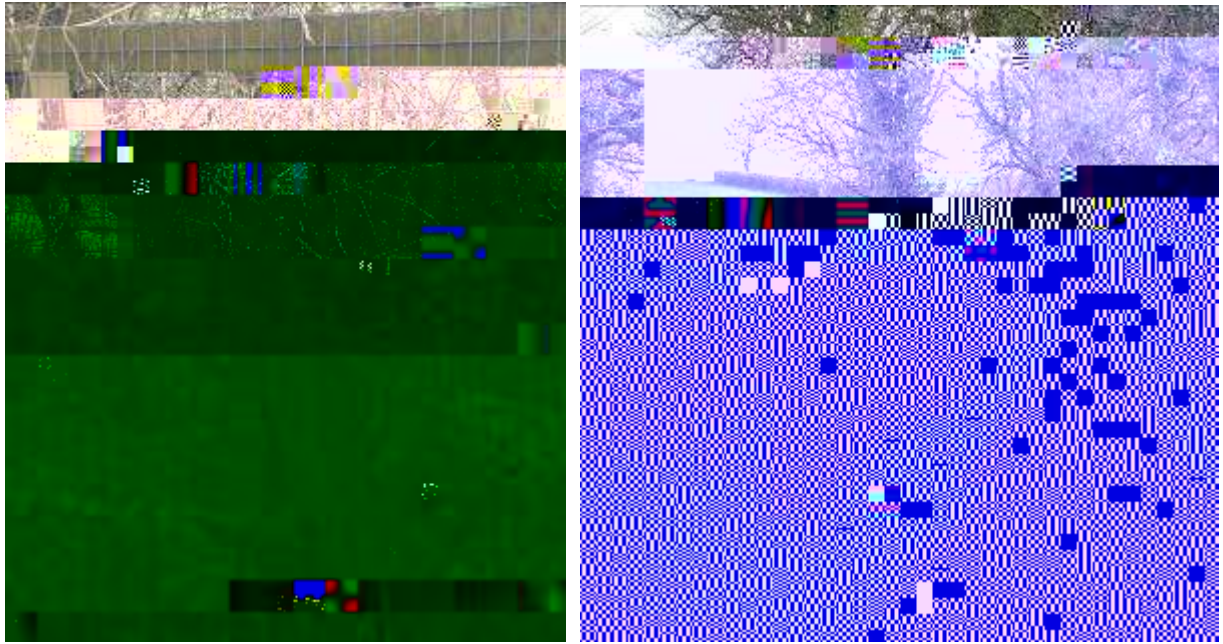
Photo's 3.7 and 3.8 - Existing drainage and path

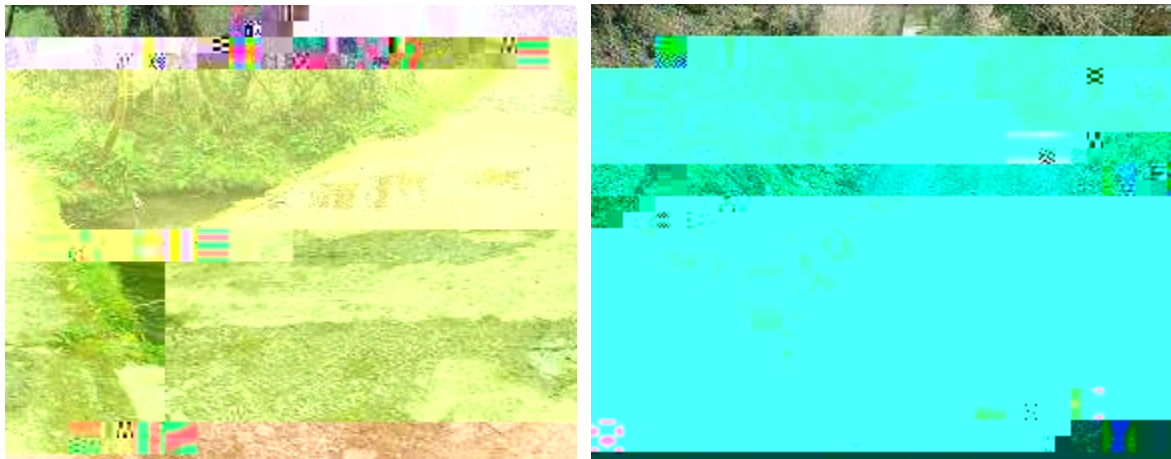
Photo's 3.9 and 3.10 - Concrete Bridge and final section to Valley Road

Towards the end of this route section there is a concrete bridge (three metres wide) over a stream without parapets and with evidence of ponding

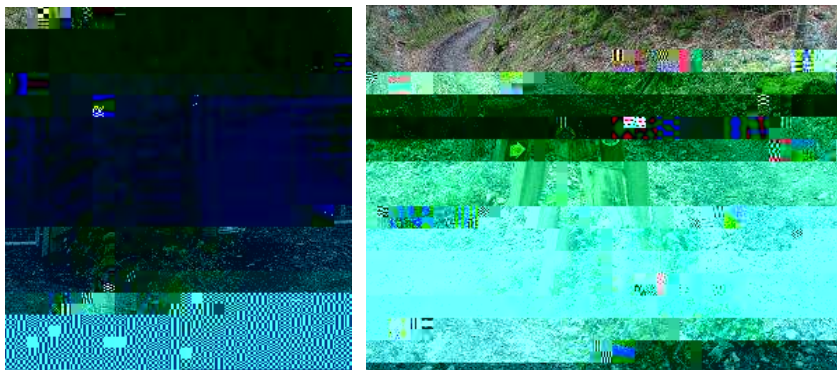
Photo's 3.13 and 3.14 – PRow from Valley Road through Canaston Wood.

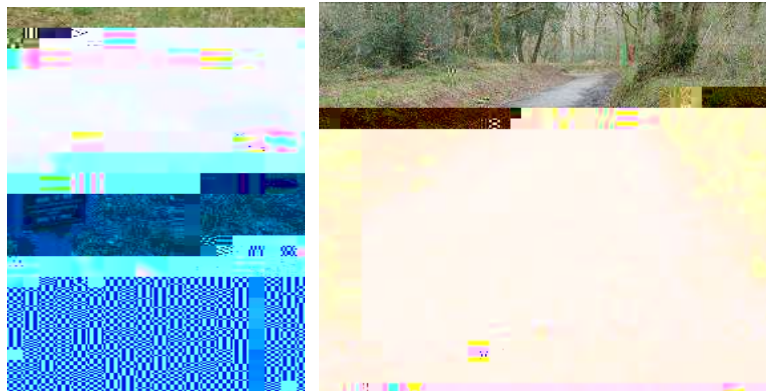
Photo's 3.15 and 3.16 – High pressure gas main and Canaston Wood path.

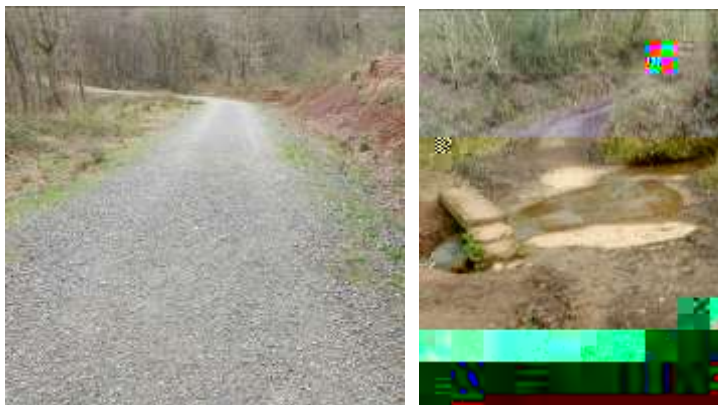
Photo's 3.17 and 3.18 – Forestry Road and ford on official route alignment.

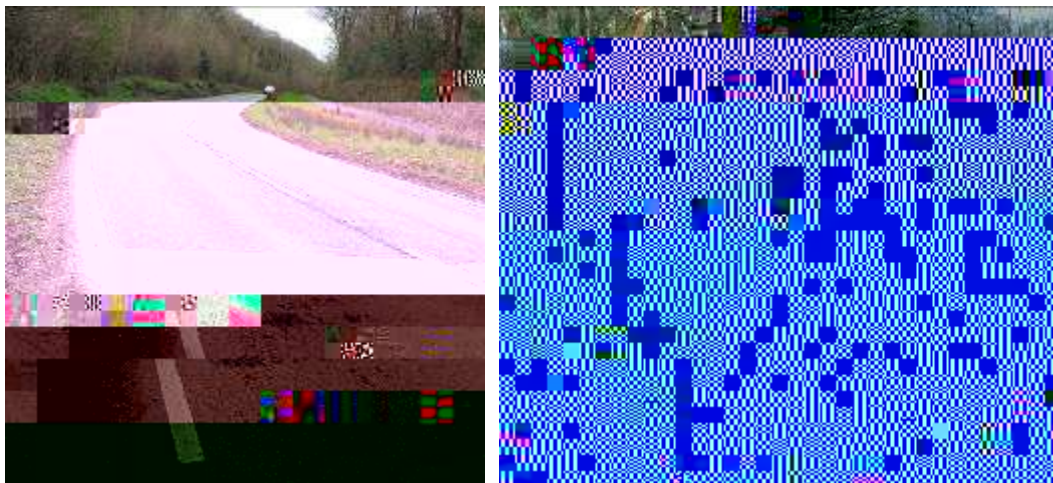
Photo's 3.19 and 3.20 – A4075 crossing point / 'Knight's Way to Blackpool Mill.

The A4075 crossing would benefit from cycle activated signs to warn approaching vehicles of cycles crossing and markings or surfacing to highlight the crossing point itself. Installation of Anti-skid surfacing on the crossing point approaches would also help to highlight the crossing location whilst also reducing stopping distances.

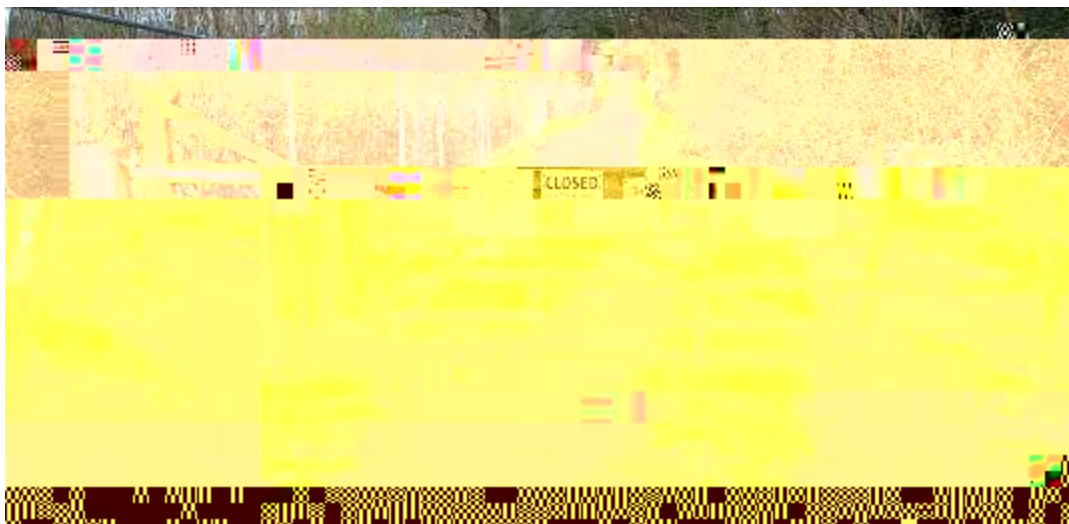
Photo 3.23- Access to Blackpool Mill and Bridge.

It is only 100 metres along the lane to the Blackpool Mill gated entrance drive. The drive is at least three metres wide with a rolled stone surface. The Mill is presently closed and therefore there is no traffic using the drive and very little traffic on the lane.

The Mill bridge is a listed structure with low parapets (1 metre). There is sufficient width to guide cycle through the middle of the bridge (5.5metres between parapets).
